Market Barriers to the Uptake of Biofuels Study

A Testing Based Assessment to Determine Impacts of a 20% Ethanol Gasoline Fuel Blend on the Australian Passenger Vehicle Fleet – 2000hrs Material Compatibility Testing

Report to Environment Australia

Orbital Engine Company

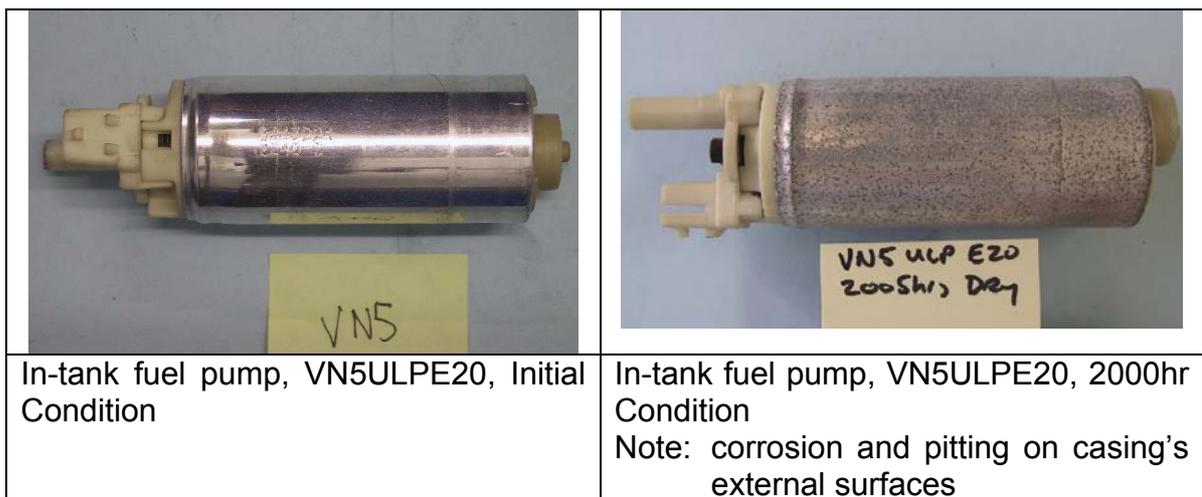
Figure 4.2 In-tank fuel pump – E20

- In-tank fuel pump (casing), corrosion and pitting on external casing surfaces
- In-line fuel pump (casing), corrosion and pitting on external casing surfaces

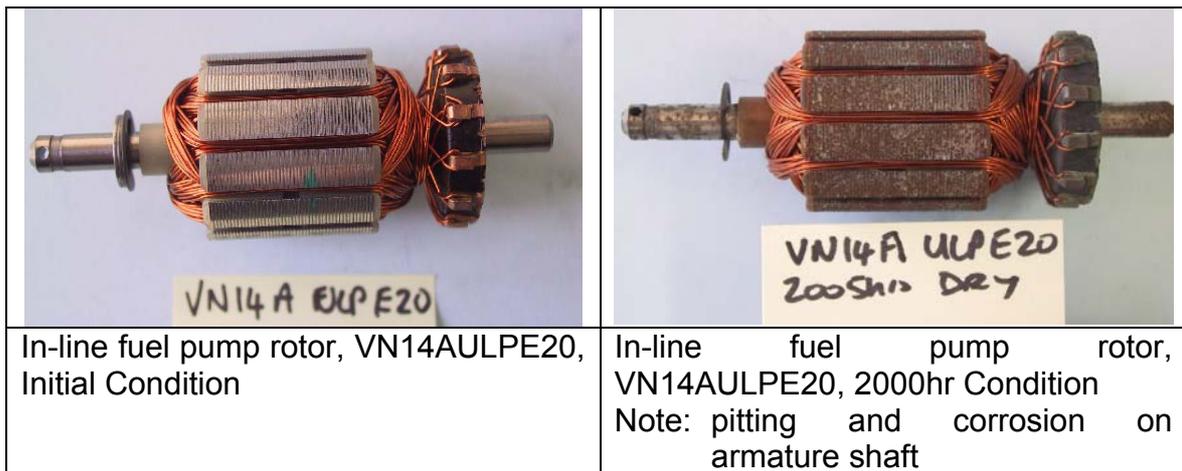
Figure 4.3 In-line fuel pump – E20

- In-line fuel pump (rotor), pitting and corrosion on armature shaft and rotor along with tarnishing of exposed electrical contacts
- In-line fuel pump (terminals), tarnishing of contacts

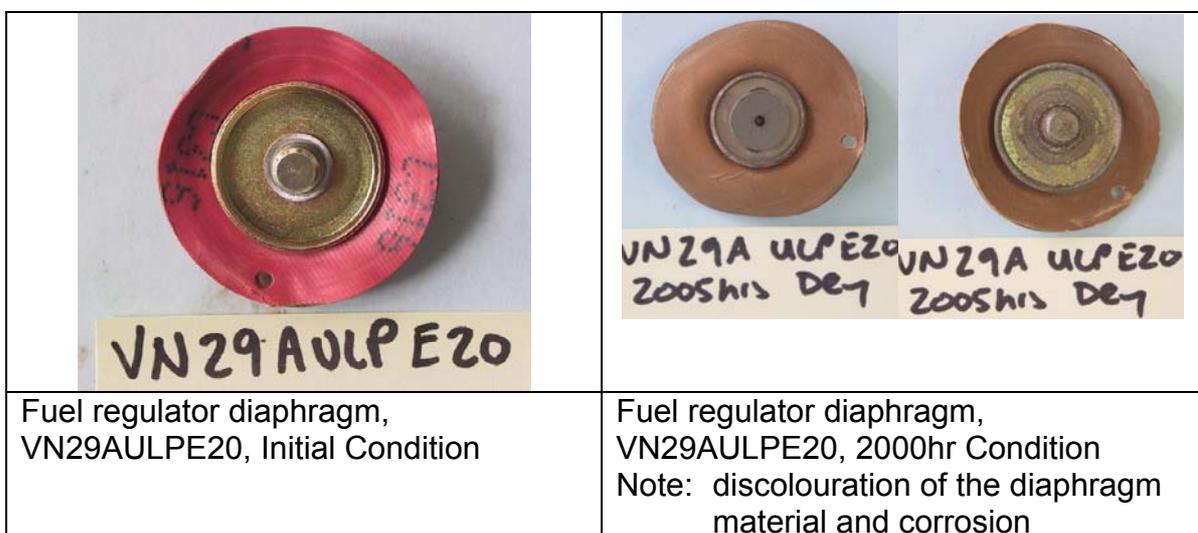
Figure 4.4 Fuel regulator diaphragm – E20

- In-line fuel pump (magnet), minor corrosion spots
- Fuel injector, corrosion on metal surfaces
- Fuel regulator diaphragm, has corrosion on metal button and diaphragm material is also discoloured

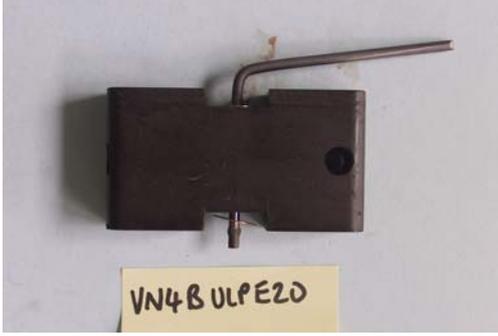
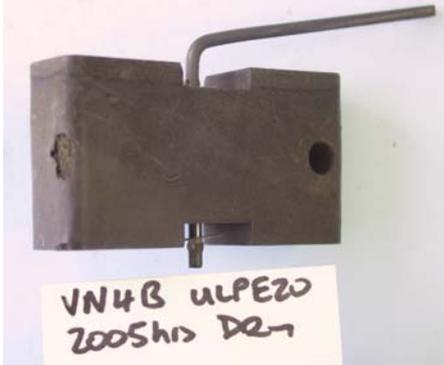
Figure 4.5 Fuel sender float – E20

- Fuel sender float (in-tank system), material starting to breakdown (some rust also on metal lever) – see Figure 4.5
- Hose – fuel tank vent, enlarged diameter
- Hose – fuel tank pipe, enlarged diameter
- Hose – return, enlarged diameter and end-delamination
- Hose – fuel regulator, loss of bend shape and end-delamination – see Figure 4.6
- Hose – vapour pipe connection, end-delamination
- Boot – in-tank fuel pump, appears softened and swollen
- Fuel injector, paint removed from casing
- Fuel rail connecting pipe, paint being removed

<p>Fuel sender float (in-tank system), VN4BULPE20, Initial Condition</p>	<p>Fuel sender float (in-tank system), VN4BULPE20, 2000hr Condition Note: material starting to breakdown (some rust also on metal lever)</p>

The risk with the breakdown of polymer materials is that there are particles loose in the fuel system that can cause clogging or blockage of filters, pumps, fuel injectors or other elements of the system.

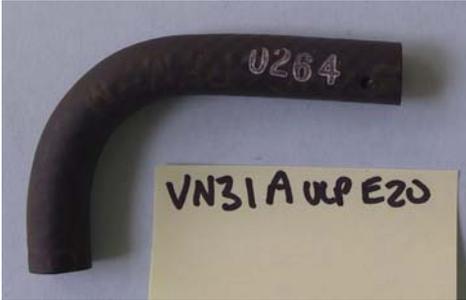
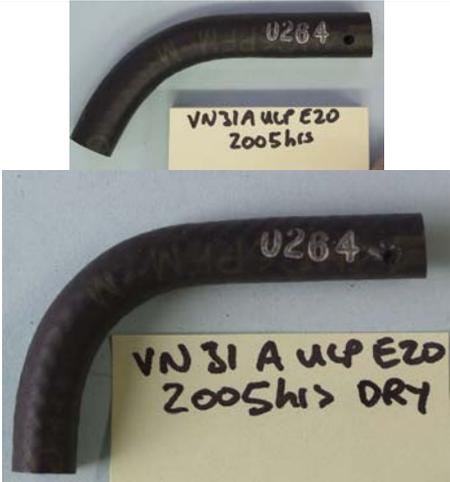
Figure 4.6 Formed fuel hoses – E20

<p>Hose – fuel regulator, VN31AULPE20, Initial Condition</p>	<p>Hose – fuel regulator, VN31AULPE20, 2000hr Condition Note: loss of bend shape (when immersed) and end-delamination. Shape mostly returns when dried.</p>

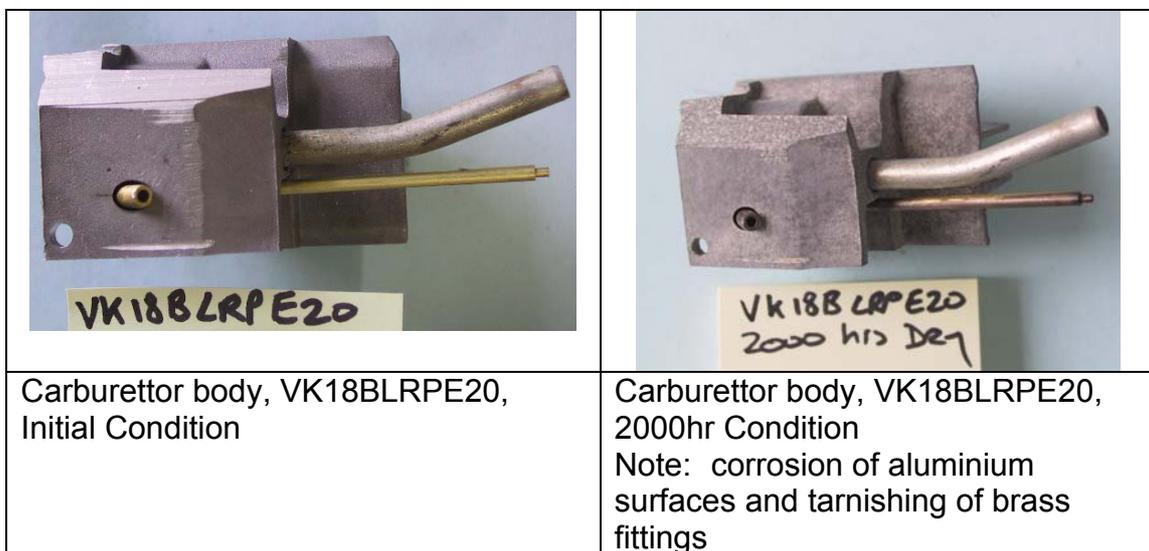
Figure 4.7 Carburettor body – E20

- Carburettor body, corrosion on surfaces and tarnishing of brass fittings – see Figure 4.7
- Carburettor float valve needle, heavy tarnishing
- Carburettor float valve body, heavy tarnishing
- Carburettor mixture adjusting screw, heavy tarnishing – see Figure 4.8
- Filler cap spring, some corrosion pitting
- Carburettor – plate, some surface corrosion
- External fuel pump – diaphragm, main pin tarnished and some corrosion on plated surfaces
- Fuel gauge sender, minor tarnishing of brass surfaces
- Carburettor – ball, some corrosion spots
- Carburettor – diaphragm, plating of metal part has started corrode/tarnish
- Choke pull-off - diaphragm, plating of metal part has started corrode/tarnish
- Fuel pump, EFI, tarnishing of connector
- Fuel pump wire, EFI, tarnishing of wire

The tarnishing of all the brass fuel system components immersed in the E20 test fuel indicates that an oxidation process has occurred. Even if tarnishing was seen with the samples in LRP, it was notably worse for parts immersed in LRP. Tarnishing of electrical connectors made of brass/copper was also evident.

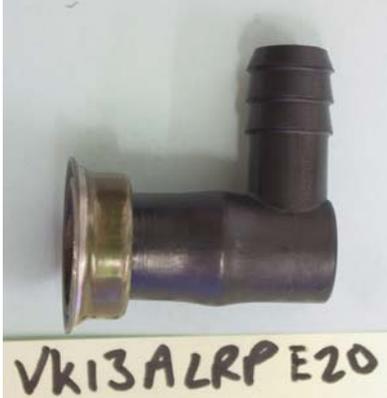
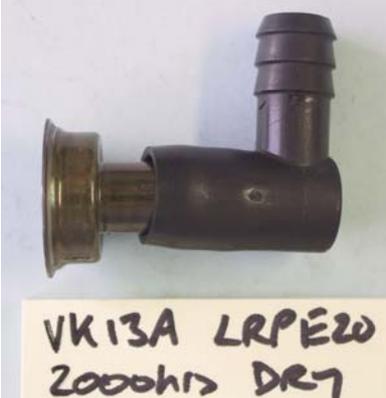
Figure 4.9 PCV – E20

- PCV valve, components have separated as polymer has distorted / swelled – see Figure 4.9
- Fuel pump, external – gasket, swelling and some signs of cracking (distortion once dried) – see Figure 4.10
- Fuel sender and pump unit (filter capacitor), insulator shows signs of splitting
- Float needle valve & seat Assy – washer, coating on washer starting to blister
- Fuel filter, external, discolouration of plastic housing
- Vapour Canister - filter, sponge separating
- Carburettor – gasket, surface dye breaking down
- Choke pull-off - filter, discolouration of plastic
- Tee – fuel filler / vent, discolouration of plastic

<p>VK13A LRPE20 2000hrs Dry</p>
<p>PCV valve, VK13ALRPE20, Initial Condition</p>	<p>PCV valve, VK13ALRPE20, 2000hr Condition Note: Components have separated as polymer has distorted/swelled</p>

Whether the PCV would separate in a vehicle situation would need to be verified.

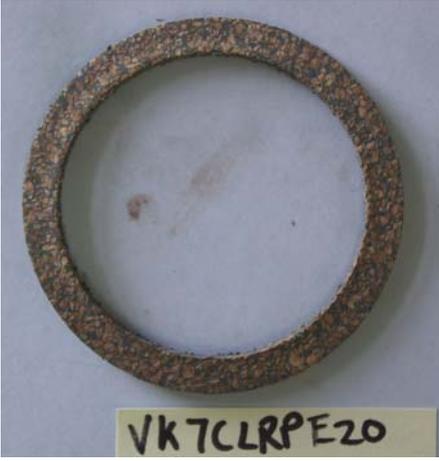
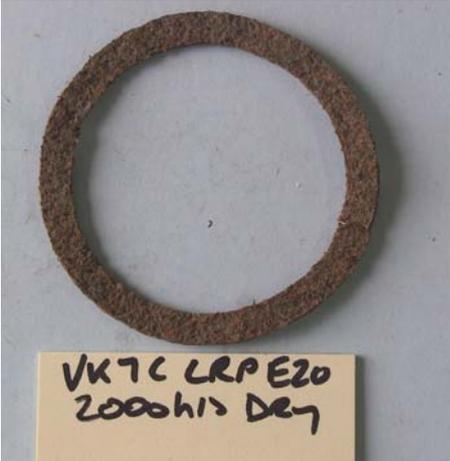
Figure 4.10 Fuel pump gasket – E20

<p>VK7C LRPE20 2000hrs Dry</p>
<p>Fuel pump, external – gasket, VK7CLRPE20, Initial Condition</p>	<p>Fuel pump, external – gasket, VK7CLRPE20, 2000hr Condition Note: swelled when immersed and showed signs of surface cracking</p>

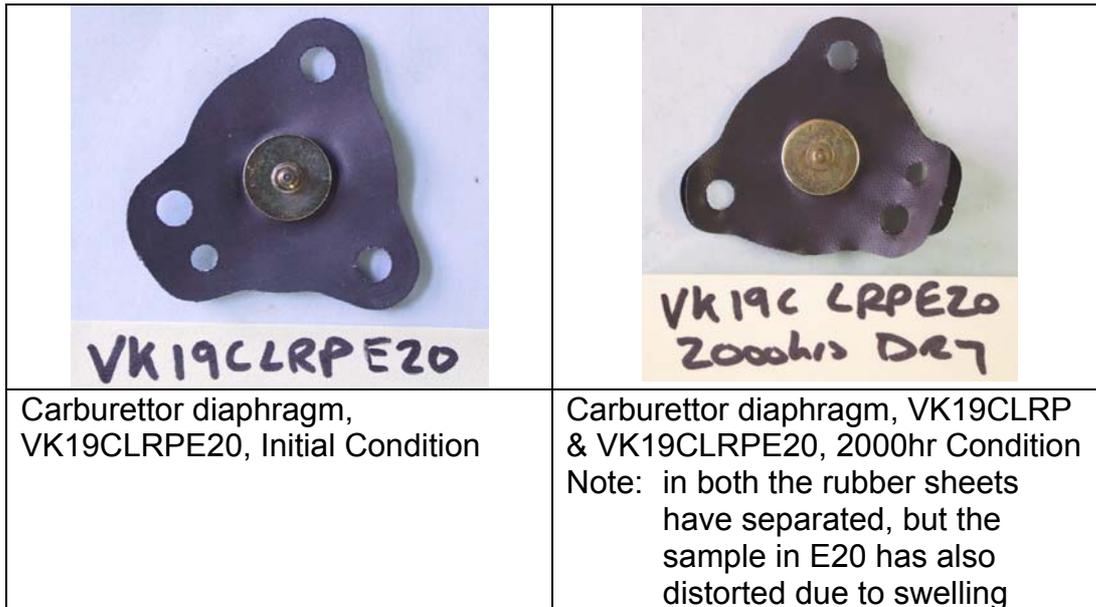
Figure 4.11 Carburettor Diaphragm – E20

Early on, the rubber sheets of the carburettor diaphragm had started to separate due most probably to the incompatibility of the adhesive with the fuels (both LRP and E20). This would not be considered a concern since the materials are clamped together in the assembly by the carburettor housing components. However, the sample immersed in E20 also showed signs of distortion due to swelling and this could be a concern.

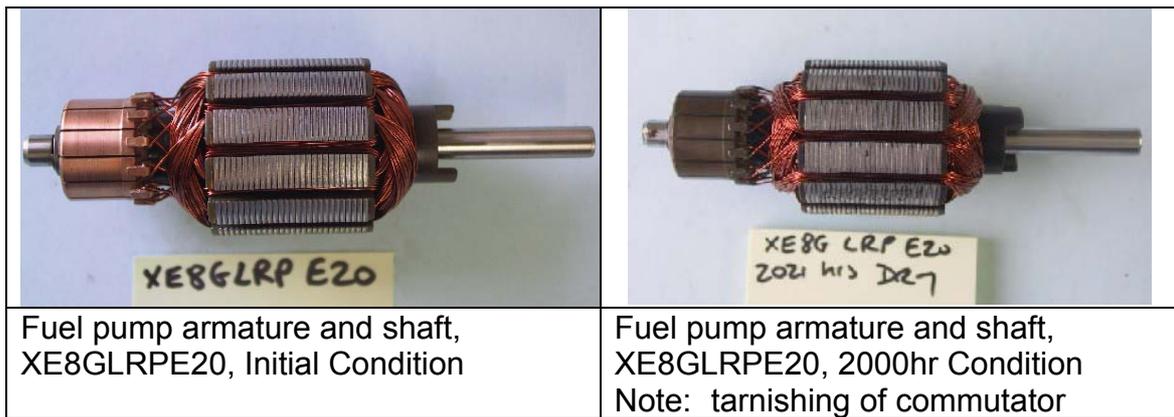
Figure 4.12 Fuel pump armature an shaft – E20

- Fuel pump terminals, tarnishing
- Fuel pump commutator, tarnishing – see Figure 4.12
- PCV valve spool, small amount of surface pitting
- Fuel tank – metal neck, some surface corrosion in spots
- Filler cap spring, small pit marks on surface
- Filler cap ring, some plating lost
- External fuel pump plate, some small spots of corrosion
- External fuel pump casing, some pitting on casing surface
- Carbon canister – lid, some small pit marks
- Carbon canister – screen, some surface attack and corrosion spots under the paint
- Fuel injector filter, tarnishing of retaining ring

Overall the corrosion severity is less than that observed on the components from the other fuel systems. The most significant concern is the heavy tarnishing of brass/copper components normally associated with an electrical role, for example the fuel pumps commutator.

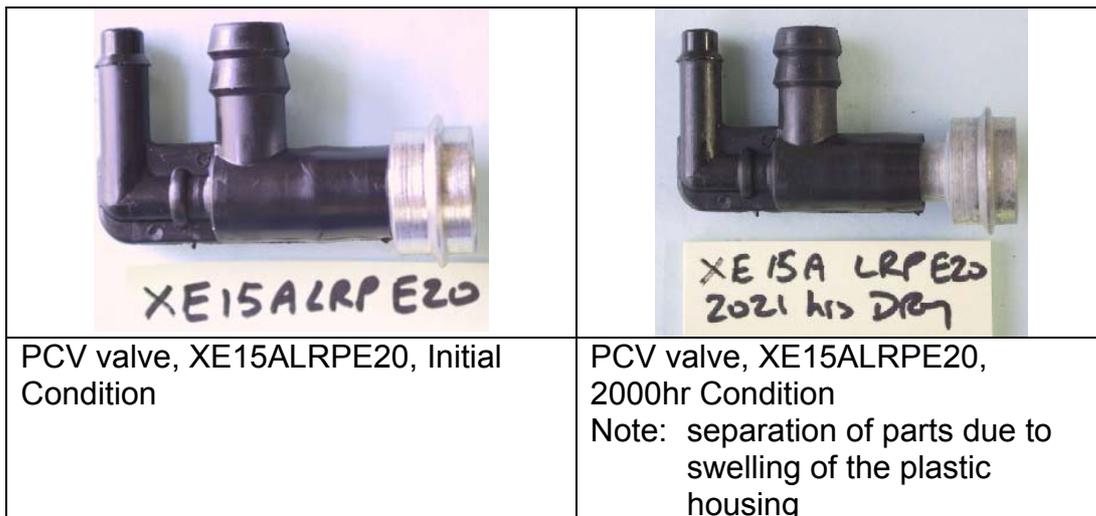
Figure 4.13 PCV – E20

- Fuel sender unit, adhesive or potting mix being dissolved
- Fuel pump relief valve, swelling of the sealing ball (as well as tarnishing of the brass body)
- PCV valve, separation of parts due to swelling of the plastic housing – see Figure 4.13
- Fuel regulator diaphragm, discolouration of both samples (swelling and distortion of E20 sample) – see Figure 4.14
- Fuel injector, paint removed
- Fuel injector o-ring, discolouration
- Carbon canister – gasket, small tears

Whether the PCV would separate in a vehicle situation would need to be verified.

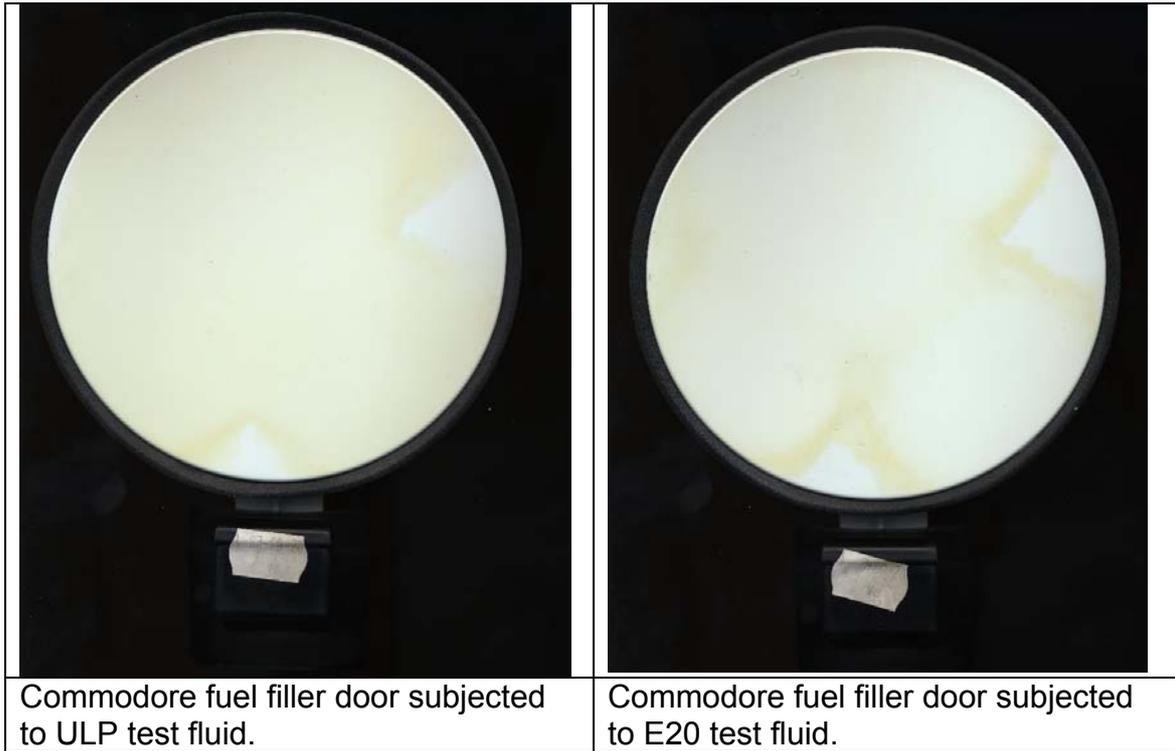
Figure 4.17 Staining on fuel filler doors

The staining is only evident on the white painted fuel filler door sample. To the naked eye the staining shown is slightly now more prominent on the

sample exposed to E20 than to the baseline ULP sample. The staining has been captured in Figure 4.17. The paint finish between the two filler door types is notably different given the difference in base material and paint type (the Ford component has a “metallic” paint finish, on a sheet metal part). These surface finish variations may be reasons in addition to the base colour that have contributed to the staining on one sample type and not the other.

The adhesive used to secure the dust seal on the Commodore part has been weakened by contact with the E20 test fluid resulting in the seal being partially detached.
